Service Advisory

Solara 3G High-Arm Option Limits Seat Cushion Width

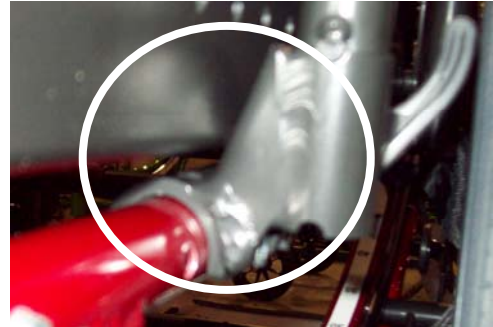
Problem Detail: When the High-Arm option is selected on the Solara 3G wheelchair, the front arm mounting cups will interfere with a Pindot ContourU seat pan, or any other seat that has the full specified chair width.

Solution: The Standard-Arm and High-Arm options are provided using the same mounting hardware. For the High-Arm option, the brackets are mounted with the cups above the chair seat rail. For the Standard-Arm option, the hardware is mounted with the cups below the seat rail.

If the High-Arm option causes the front mounting hardware to interfere with seat pan / seat cushion mounting, the chair will need to be changed to the Standard-Arm configuration. This will reduce the maximum arm rest height by 2 ¼ inches.

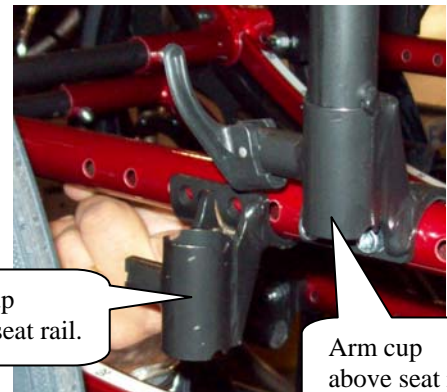
Arm cup
below seat rail.

- Remove the two front arm cup brackets.
- Install the bracket taken from the right side on the left side of the chair, with the cup oriented below the seat rail.
- Install the bracket taken from the left side on the right side of the chair.
- Repeat the procedure of trading left and right brackets on the two rear arm brackets, mounting the cups below the seat rails.

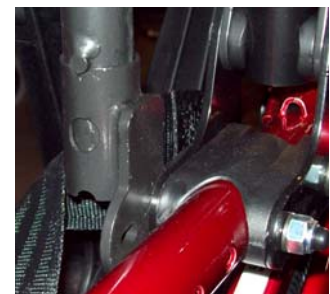
Arm cup
above seat rail.
